# Z4-forum.com

## Roof Micro Switches and Hall Sensors - Fixes and info

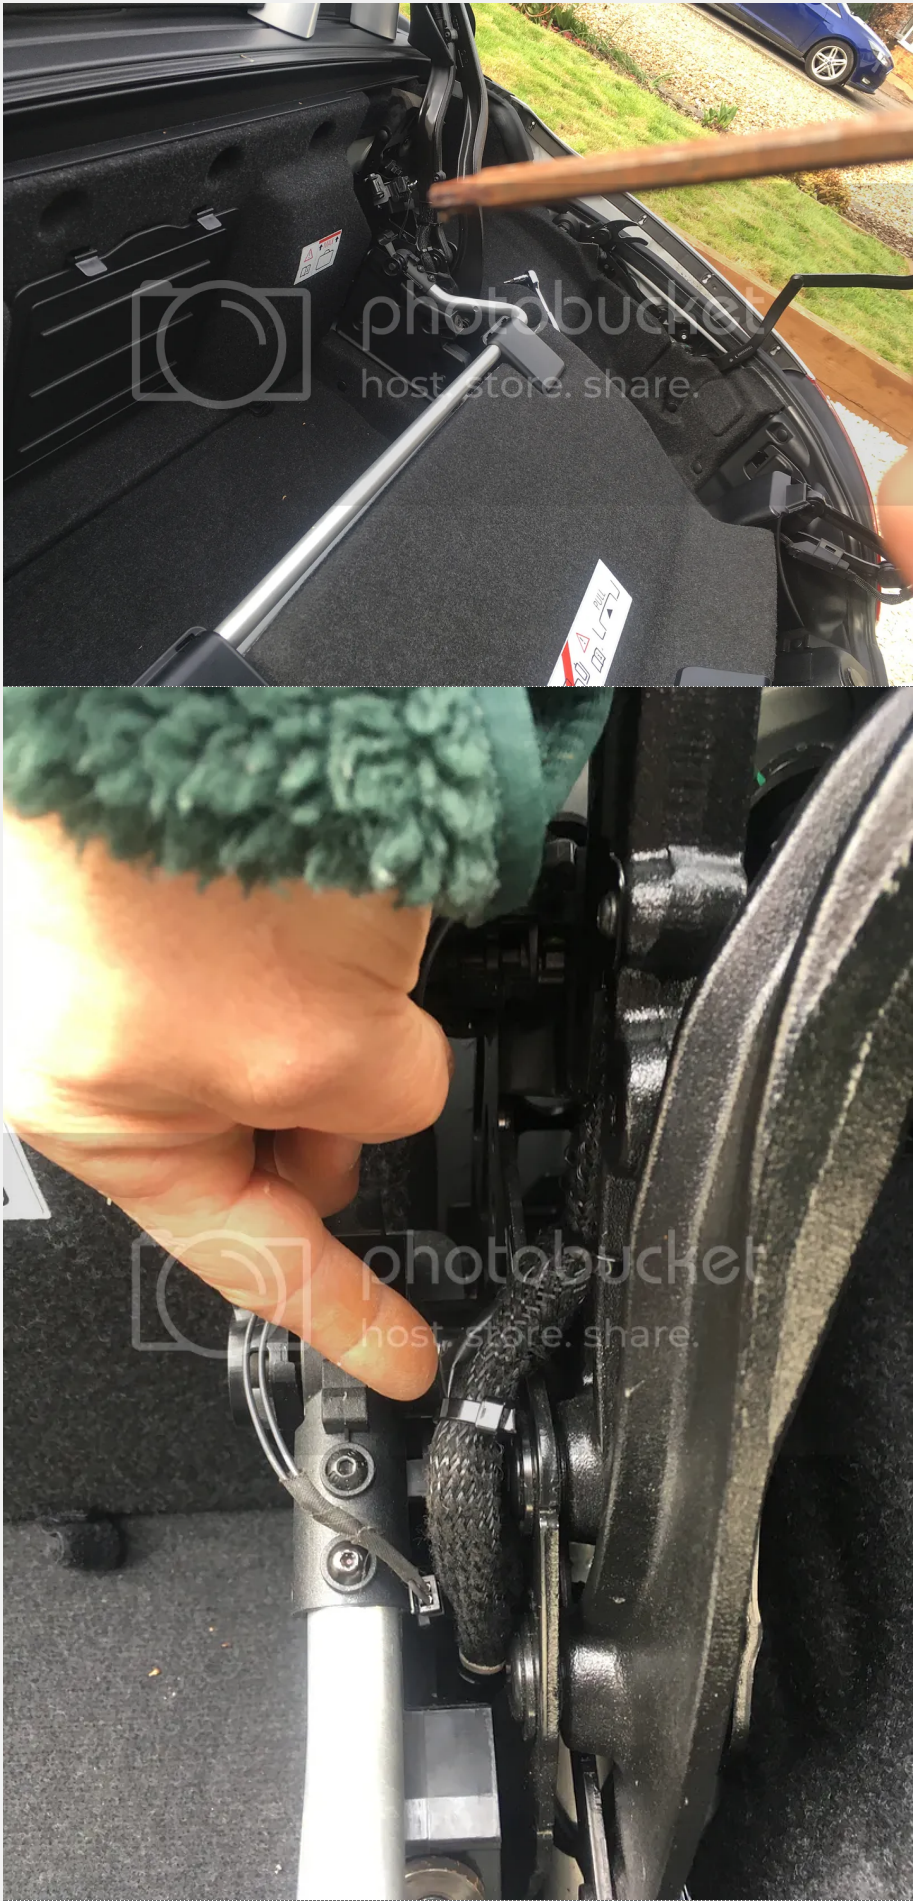
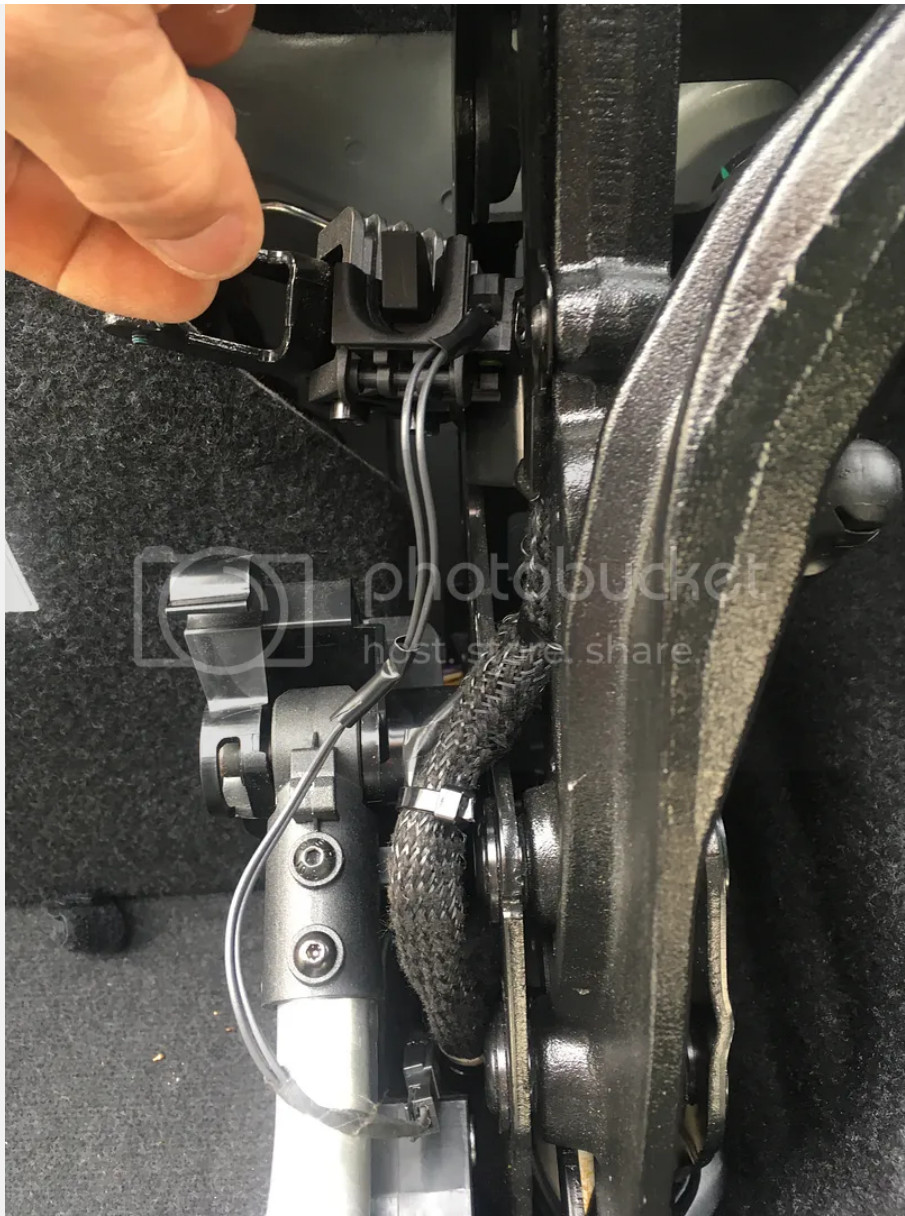
Location ...., I'm using a rusty old Torx driver for contrast in the pictures, this is not my normal tool condition !

I started with the easy stuff, the roof was triggering to open close, so I knew the boot partition hall sensor was working. The roof unlocked and folded into the boot and unfolded and locked back onto the screen so I was pretty sure that the roof panel micro switches were working and the screen micro switch was working . This would also lead me to believe that the Roof rear window panel micro switches were working too . Something was not triggering the boot to close after opening and the roof not to lock onto the screen and close the boot upon closing . First I tried the easiest micro switch to get too ( well who wouldn't ! ) . The Roof hinge boot micro switch .

When I went to inspect this switch I noticed that the main wiring and hydraulics for the roof run up the main hinge arms near this switch and that the mounting for the swivel arm of the boot partition is also right next to the main wiring loom and the micro switch wiring is cable tied to the main loom. The proximity of the loom, the hinge and the swivel for the boot partition is very tight. On inspection I could see my loom casing ( the outer sleeving ) was chaffed and I could see the inner wires.

I dutifully cut away the damaged casing , ran a continuity test on all the wires and luckily they were all ok, but if a break in a wire is found here it's not difficult to repair. Then I repaired the casing and rerouted the wiring carefully and secured it with new cable ties. Having removed and replaced the micro switch, the roof was no different , but the switch wasn't expensive.

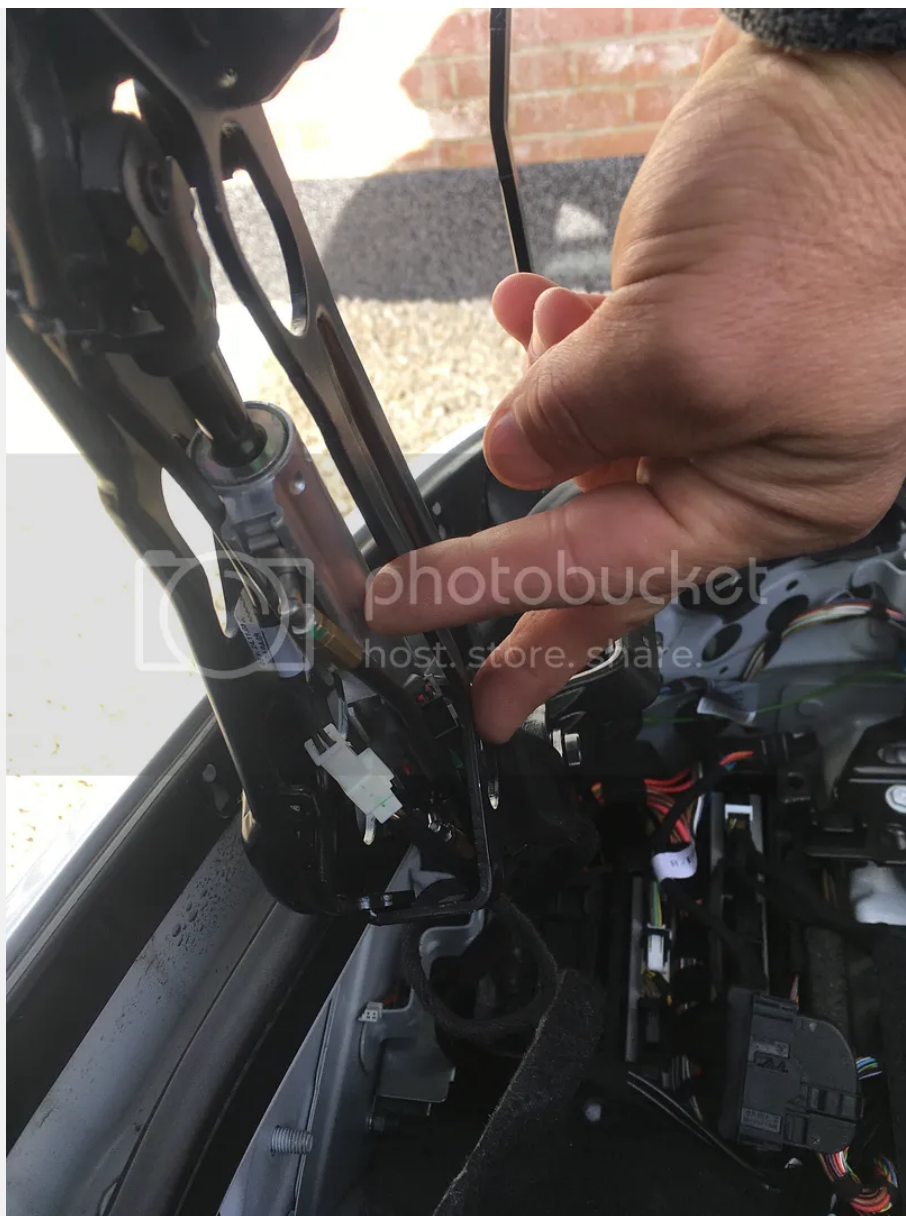
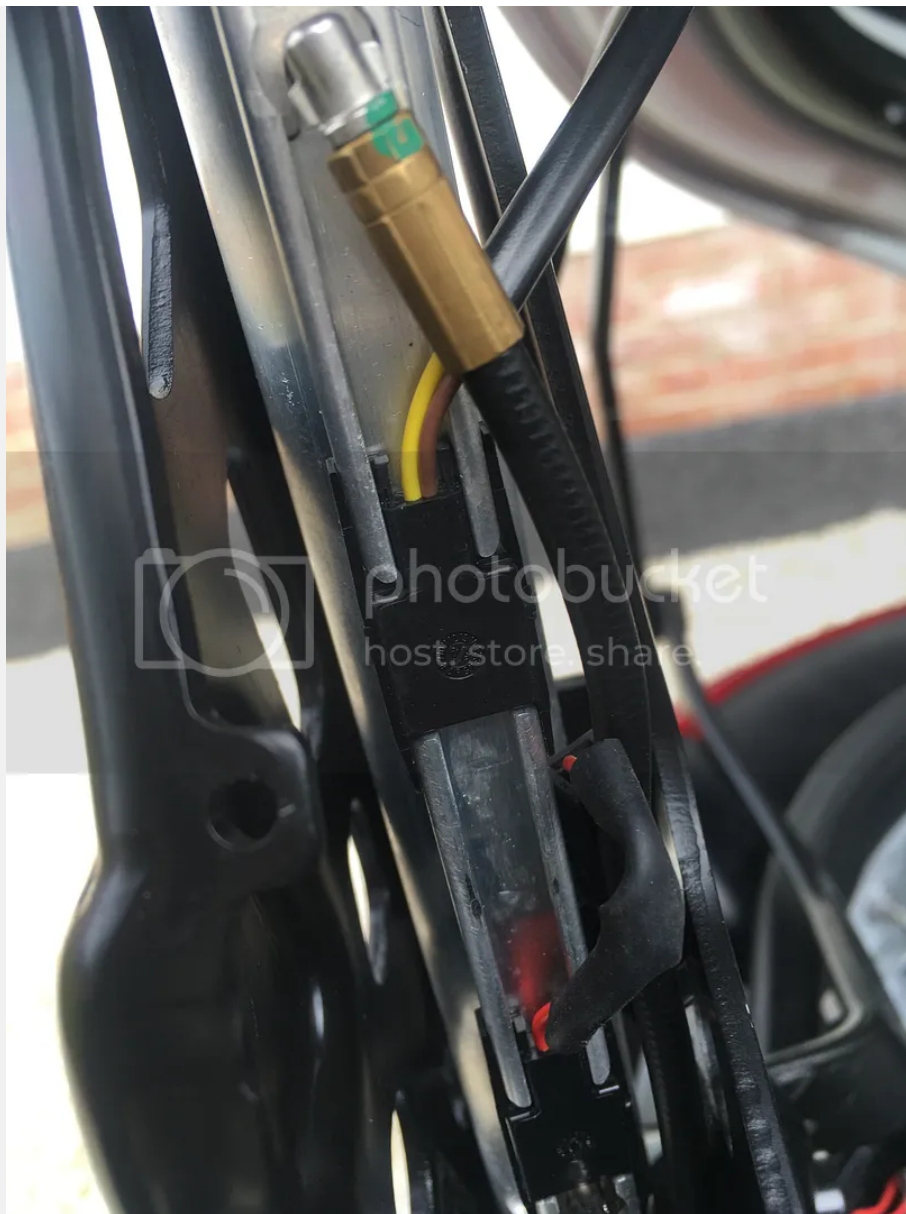
Hall sensors

At this point I decided that as I could see the micro switches and hall sensor connections I would unplug one at a time and see if the roof operation acted any differently before I unbolted the hinge. With the micro switch unplugged the roof wouldn't move from where it was with the boot open, but with one of the hall sensors unplugged , the roof did exactly the same operation as it was, so I thought I'd start with that hall sensor .

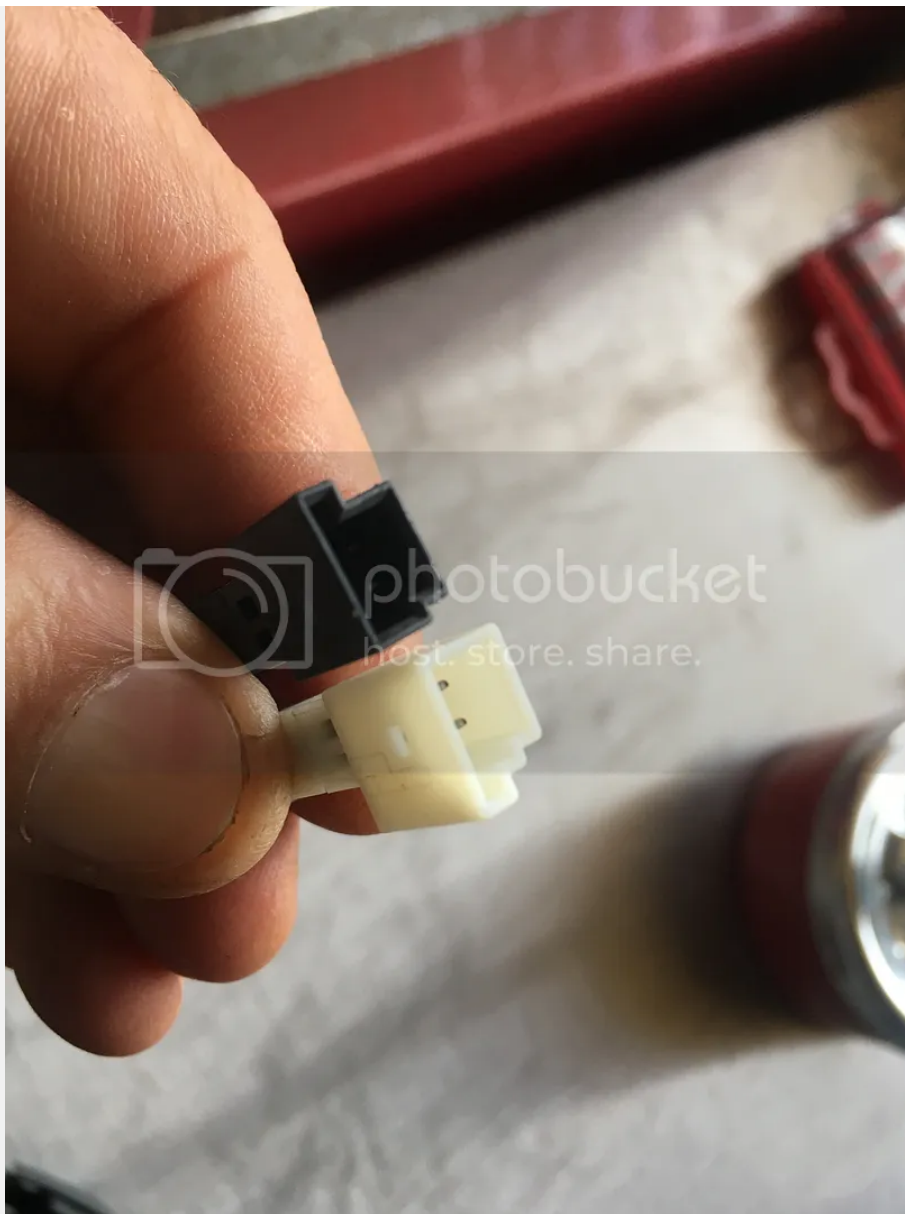
Black is the new type connector, white is the old type .

I had bought both a micro switch for the right hand hinge( they are handed ) and one of the hall sensors ( they are both the same sensors , but from new,the car will have one with a short lead and one with a long lead , as a spare part they only sell the long lead version !) however, the connector on both the micro switch and the hall sensors have been changed from the old versions to new ones ,so you may have to chop the new connectors off the new plug and solder on your old plugs to facilitate proper connection. This is what I had to do for the Hall sensor( BMW technical services tell you this is your only option for the hall sensor connectors,( see pictures below ) the micro switch connector is available with some additional parts to modify but honestly I'd chop and swap these too if I had too, it's very easy) .

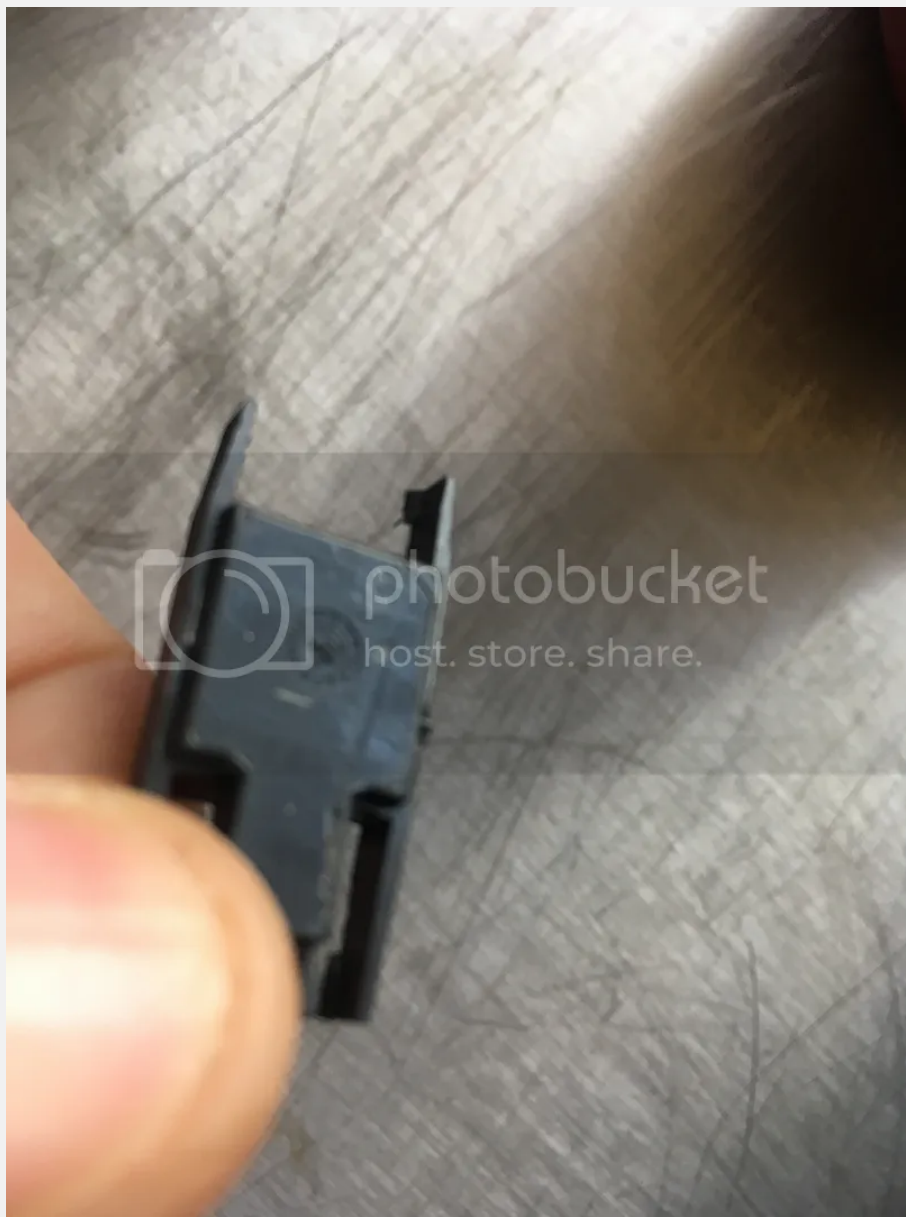
When I carefully inspected the old hall sensor I can see it is cracked around the outer edge so this may be something to check for. It's only a magnet but I guess any damage could cause issues.

My faulty sensor is definitely cracked like your above link suggests so I suspect that is what cause the issue here.

that too ( it just unscrews with two small screws ) I fitted the new hall sensor (with chop and swap plug ) and refitted the hinge . With every wire carefully cable tied back into position I closed the roof completely , pressed the open button and .....result it's all back to working as it should .

No re coding was required, once the faulty sensor is replaced the roof clears itself of fault codes, although they may well still be stored in the cars brain .

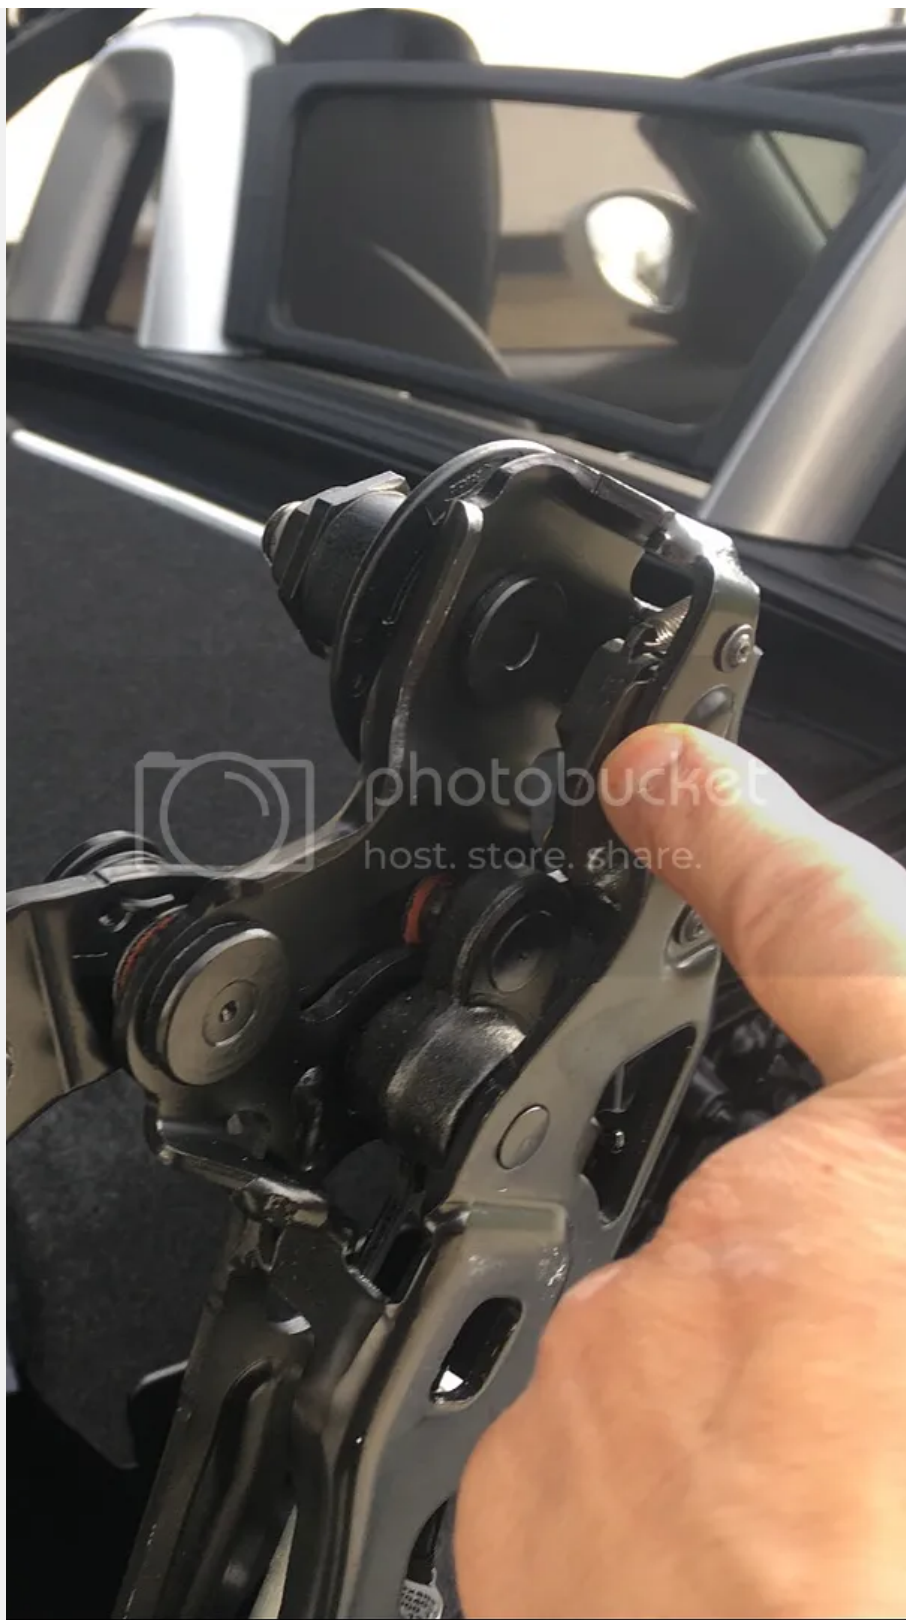
If your roof opens , folds into the boot successfully but the windows fail to raise and the boot won't open or the roof closes and leaves the rear window cam shell on top of the roof and the windows fail to raise.

.....this is likely to be a faulty boot switch micro sensor .items 4 and 5 on the parts diagram , (microswitch ring buckle coupling )

I've done three of these now, but the sensors are handed left and right and it's just a game of luck for which one has failed. They aren't expensive at 16 quid a side so I would suggest get both sides and this should solve your issue .
