# Z4-forum.com

## Roof Micro Switches and Hall Sensors - Fixes and info

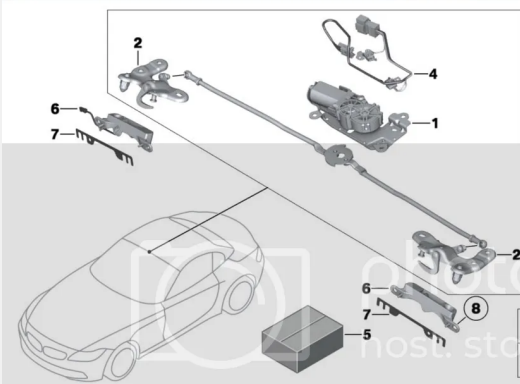
Items 4 has two switches in it and item 6 has one

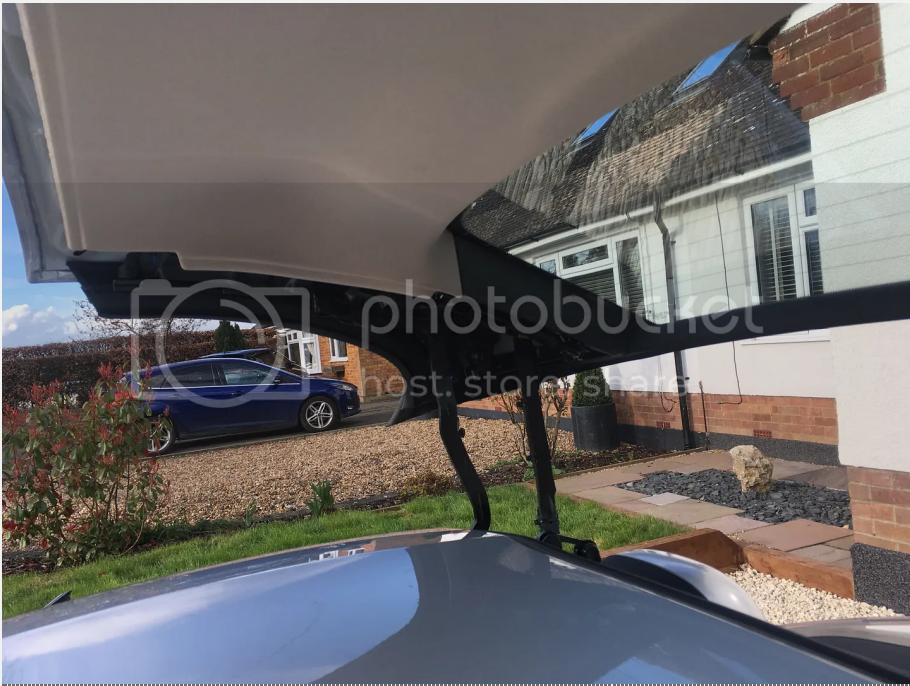
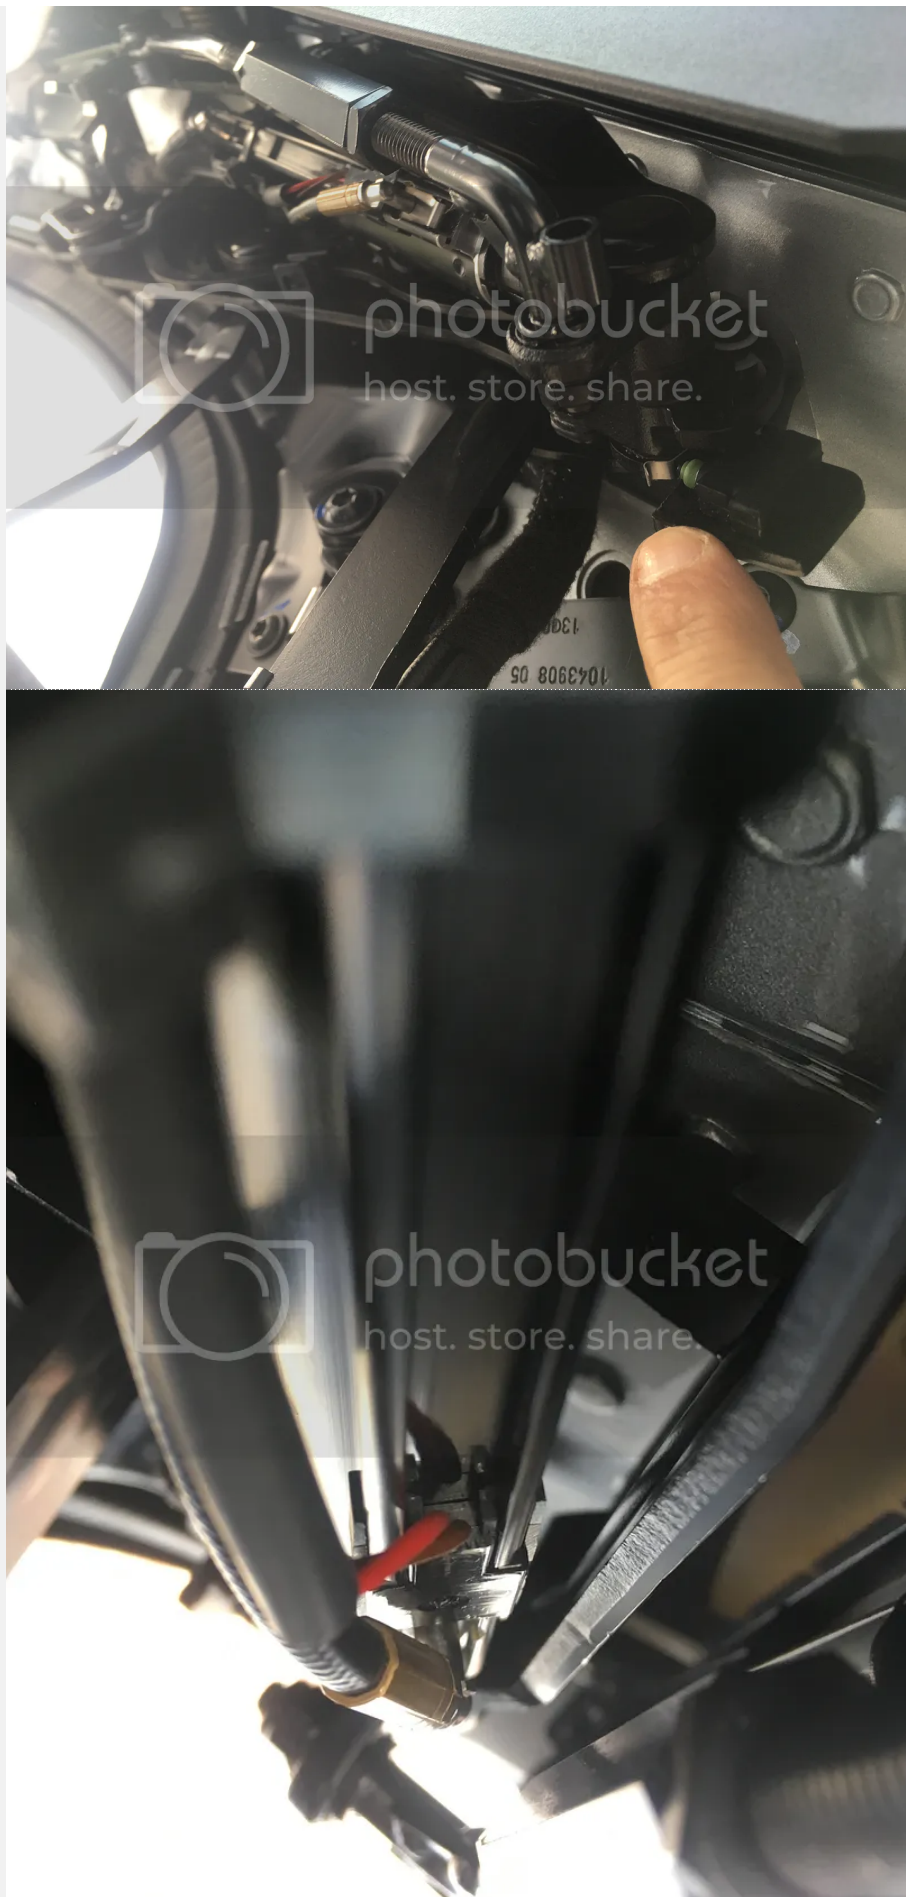
Location of micro switch and hall sensors on the car

The Rear window roof panel

Two micro switches, these are located at the bottom edge of the side beams ( to the sides of the rear window glass) and can be seen only if

you stop the roof operation whilst the rear window panel is on top of the top roof panel and look under the back edge of the rear window panel at the side beams you can see these micro switches at the bottom of the internal mechanism each side. They are hard to spot .

Items 2 and 3 are the switches and one of items 7 which is fitted in the right hand hydraulic ram of the rear window roof panel down the side of the rear screen

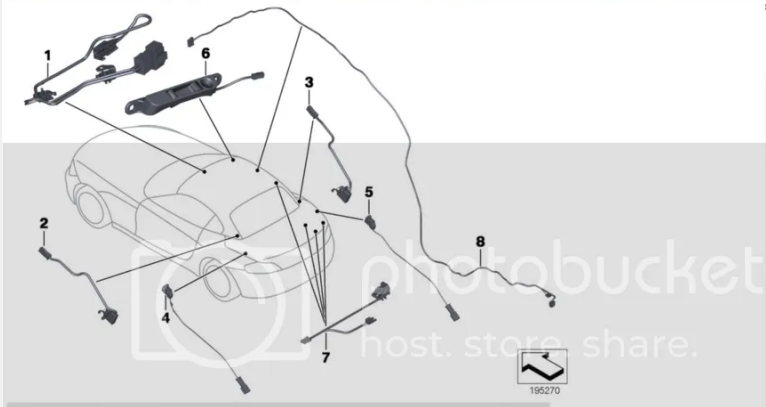
Parts picture

Rear boot side hinge mechanism

2 micro switches . When the boot is raised for roof opening/closing if you stand at the fuel filler cap position, and look down the inner edge of the

boot space you will see the hinge mechanism for each side of the boot lid . Now if you look at the boot in its raise position ,you will see a big plastic hook/clam claw that locates onto a lock pin on the boot hinge mechanism ( when it's closed ) , just inside this lock pin ( towards the body panel, behind the pin mounting ) is a micro switch with a small metal spring on it . There is one each side. , it pretty hidden but careful inspection will reveal the location . One micro switch for each boot side mechanism .

Items 4 and 5 are the micro switches here,one on each side hinge left and right , and 2 x item 7 are the hall sensors fitted into the right hand side boot hinge hydraulic ram ( none in the left hinge ram )

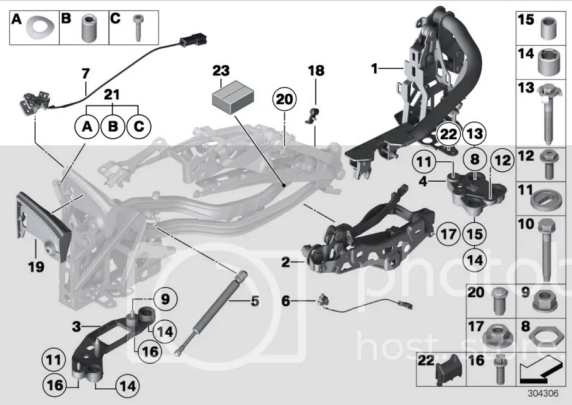
Roof main hinge

One micro switch. The roofs main hinge is mounted to the rear boot floor/ bulkhead . Two hinges one each side behind the seats (in the boot). The roof locks into the boot space using the same mechanism that locks it to the front windscreen. The roof lock hooks lock onto pins mounted on the main roof hinge that mirror the lock pins on the top edge of the screen. Just next to the drivers side roof lock boot pin( the bits the hooks lock onto ) ,is a micro switch. It's set into a small plastic cone, the micro switch trigger is in the centre of the cone and is operated when the roof guide cone locates into it. This switch is also triggered when the boot is closed, a cone on the boot can be seen with the boot up for roof opening/ closing , that locates in the micro switch when the roof is up and not in the boot .

Item 7 is this micro switch .

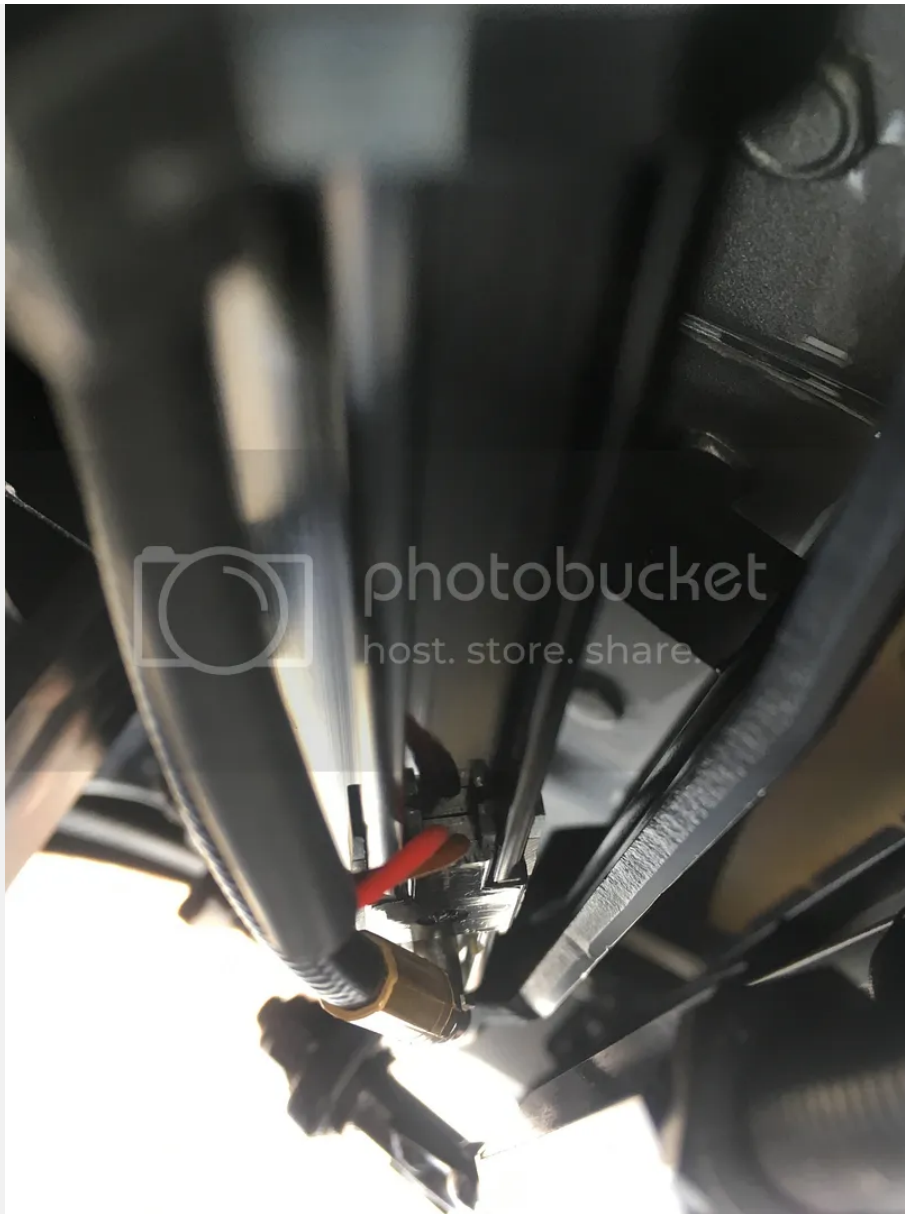
Roof rear window panel

The operating hydraulic rams are for the rear section of the roof rear panel are located on the inner section of the side beams ( the section of rear roof panel that run down the side of the rear window glass) . The drivers side ram has a hall sensor located into the ram casing . It's about 1cm square and has two wires running to it. It's the same sort of sensor that is used on the boot hinges that I will describe next . These type of sensors just clip into the rams and are located by means of a cut out in the rams casing so once in they shouldn't move position . Clipping them in and out isn't the problem here for replacement , it the wiring route that makes it difficult to replace .

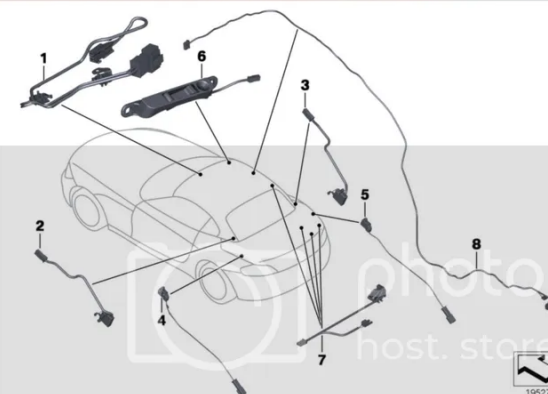
All hall sensors are listed here as item 7 , they all come now with the same length cable, your car may have long and short lead versions but BMW only sell the long lead version now.

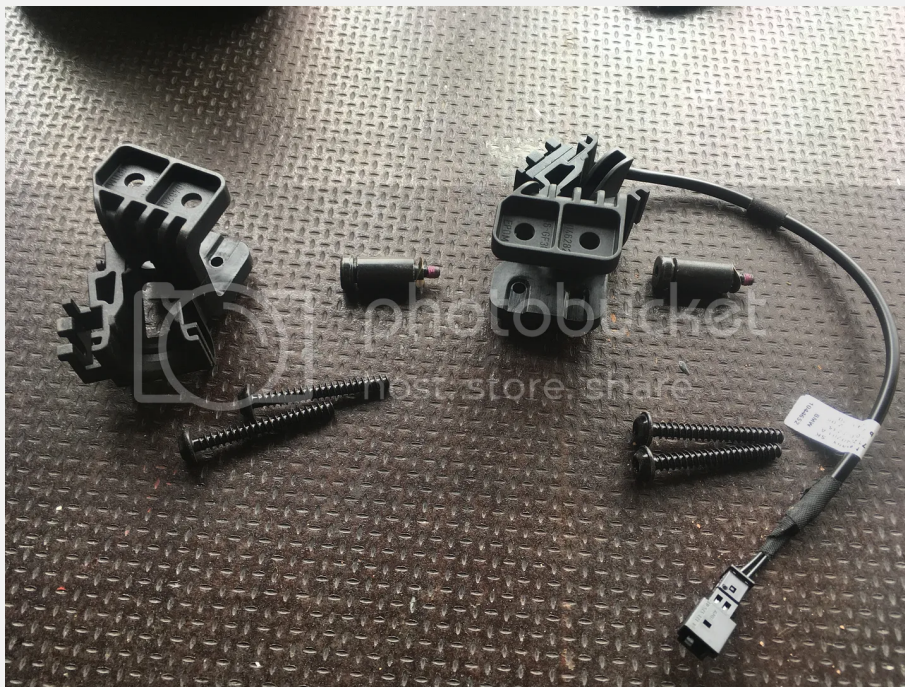
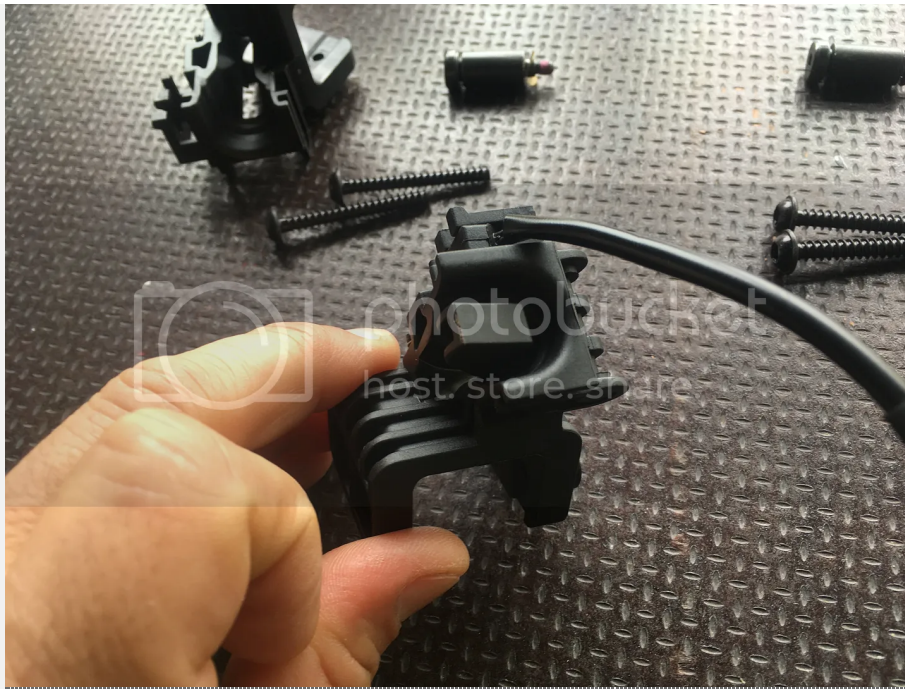
It comes as a kit, obviously If everything looks ok your only interested in the switch.

I dutifully cut away the damaged casing , ran a continuity test on all the wires and luckily they were all ok, but if a break in a wire is found here it's not difficult to repair. Then I repaired the casing and rerouted the wiring carefully and secured it with new cable ties. Having removed and replaced the micro switch, the roof was no different , but the switch wasn't expensive.

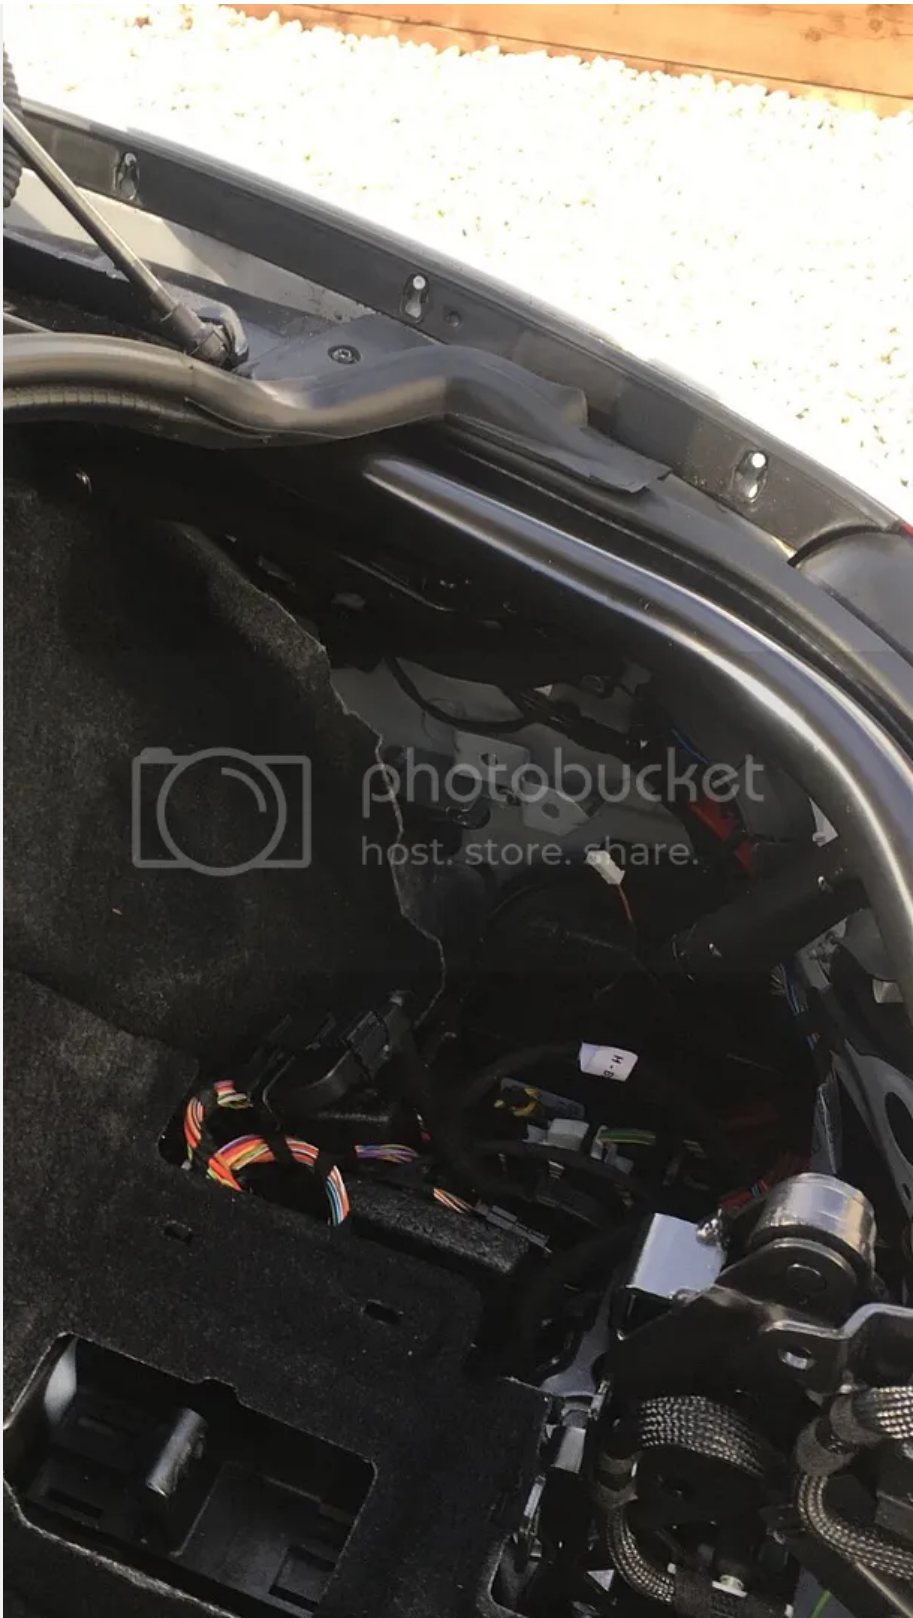
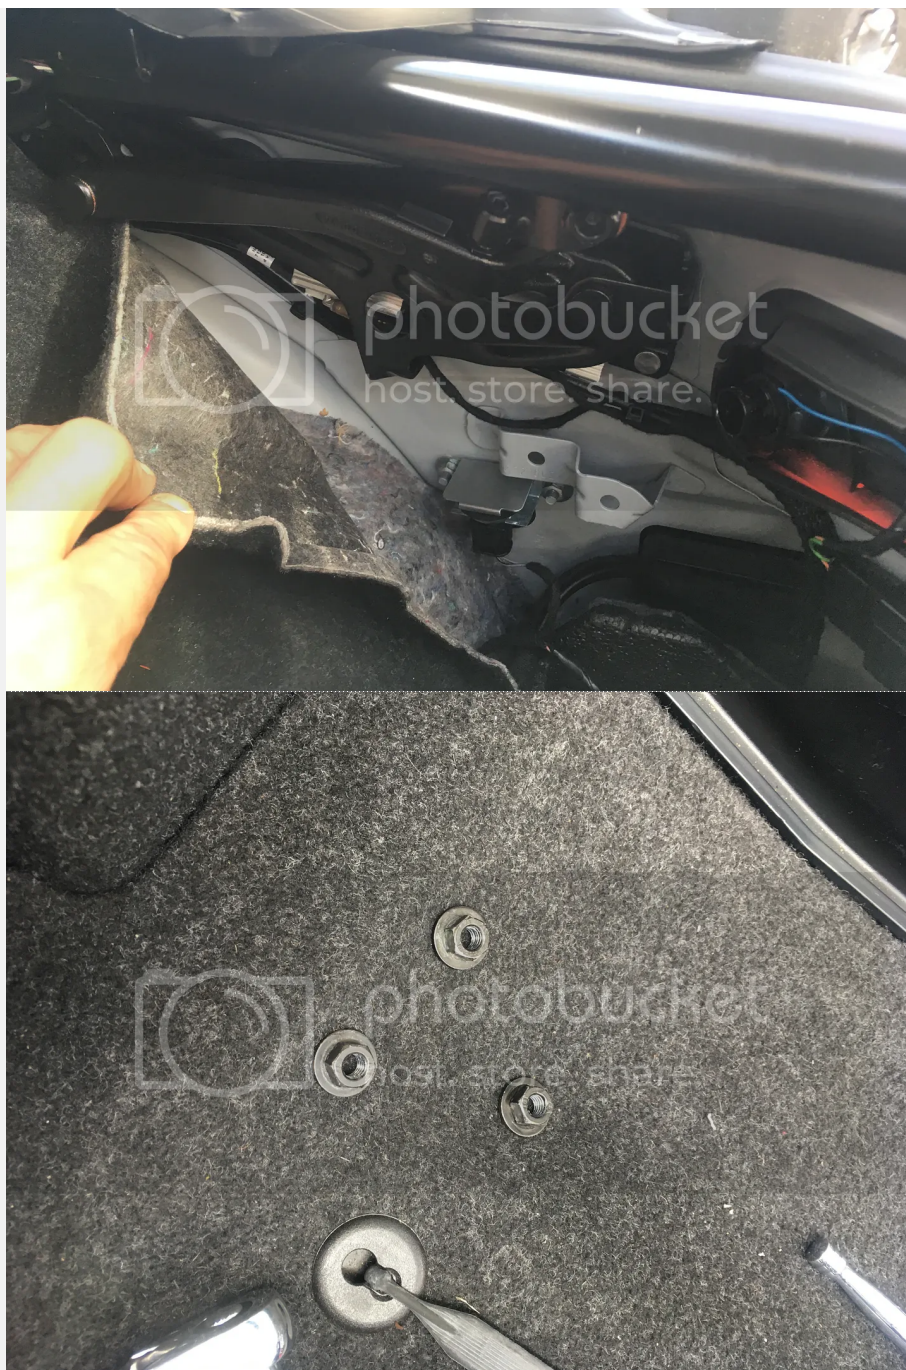
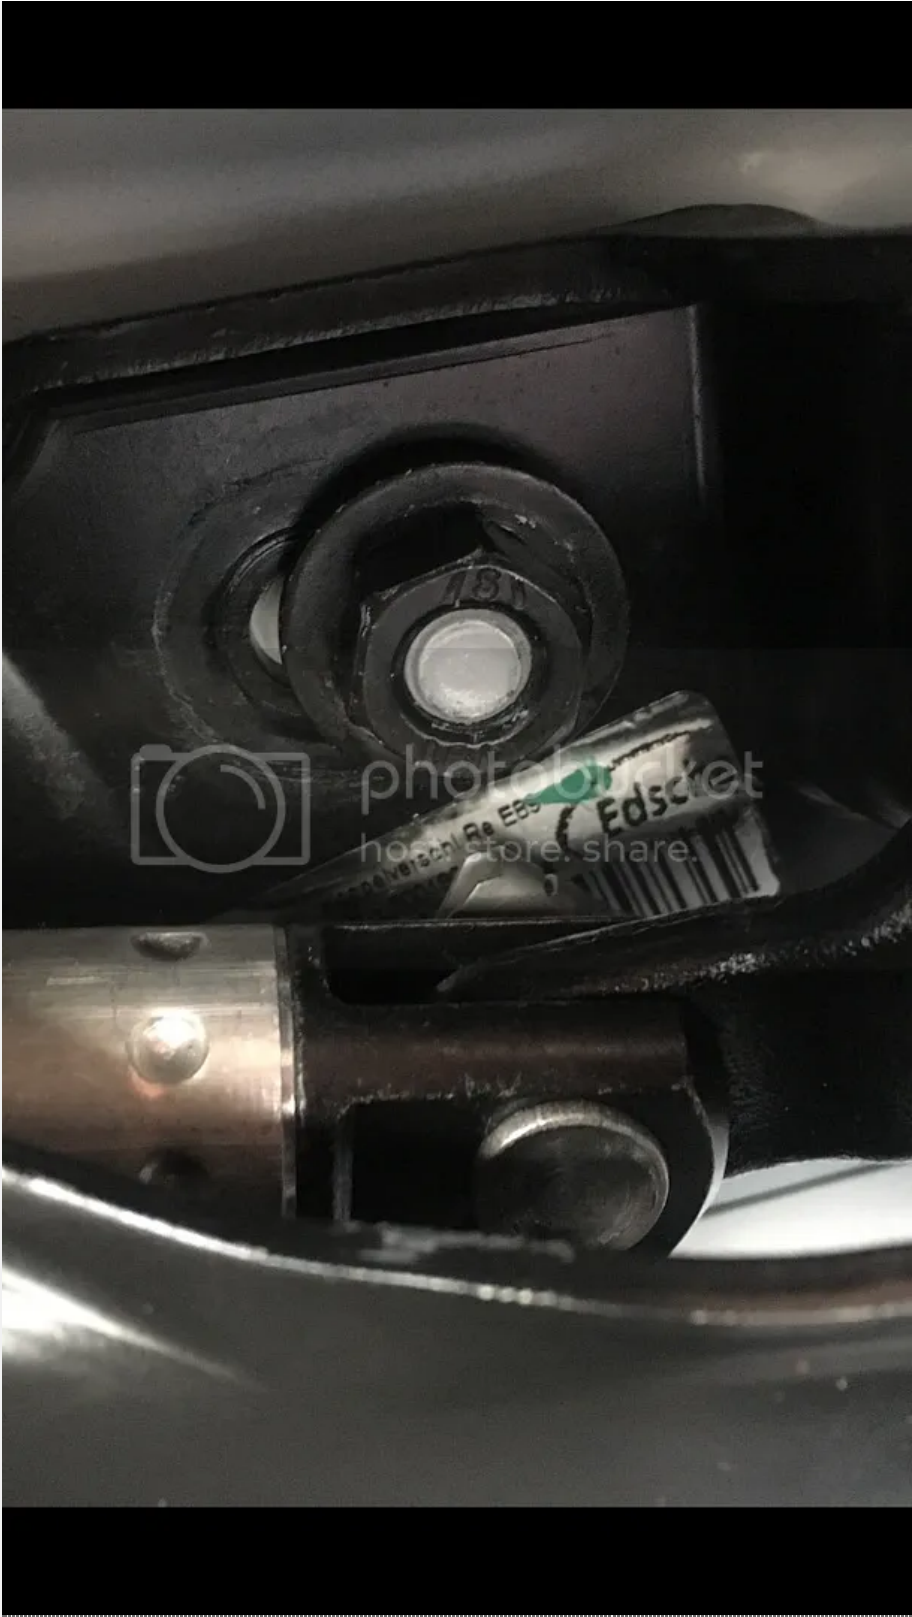
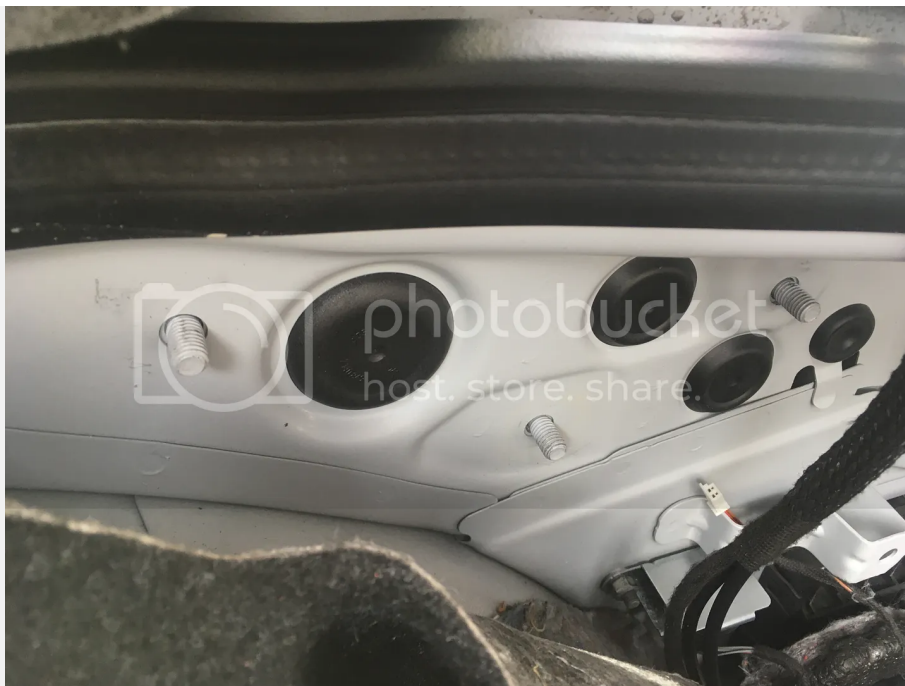
Next I turned my attention to the boot hinge micro switches and hall sensors . The drivers side has both a switch and 2 hall sensor, the passenger side only has a micro switch . To replace either the micro switch or the hall sensor you have to unbolt the hinge. You can do this fairly easily if you do only one hinge at a time, don't unbolt both hinges at the same time, one only. First you'll need to remove the inner trim panels around the boot hinge you are doing , to get access to the hinge bolts . They are fairly easily removed , you just need a trim panel tools for the push in expansion plugs and after 2 mins you should be able to see the hinge. With the boot opened for roof operation, look at the hinge and you will see 3 x 13mm nuts holding the hinge to the body.

At this point I decided that as I could see the micro switches and hall sensor connections I would unplug one at a time and see if the roof operation acted any differently before I unbolted the hinge. With the micro switch unplugged the roof wouldn't move from where it was with the boot open, but with one of the hall sensors unplugged , the roof did exactly the same operation as it was, so I thought I'd start with that hall sensor .

**BEFORE** you start undoing these mark around the nuts, so you can clearly see where they need to be repositioned . These hinges are adjustable and basically determine where the boot alignment goes when the boot is closed. If you don't get the nuts back in the same place on the hinges the boot may not close correctly or the panels may not align correctly . For me 2 nuts were accessible with a socket but the third, due to the ram position impeding access with a socket had to be undone and retightened with a spanner.

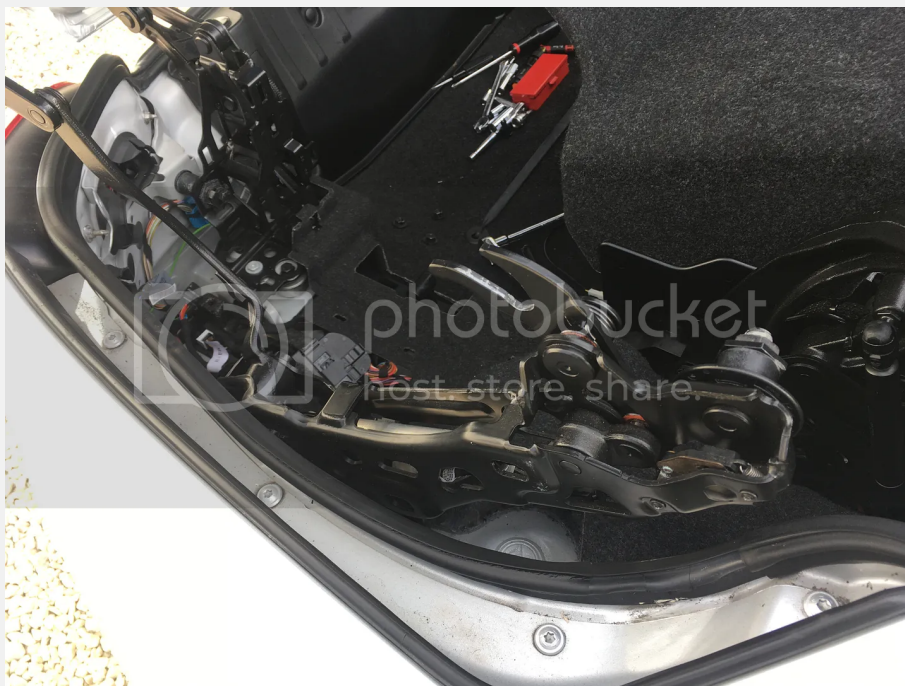
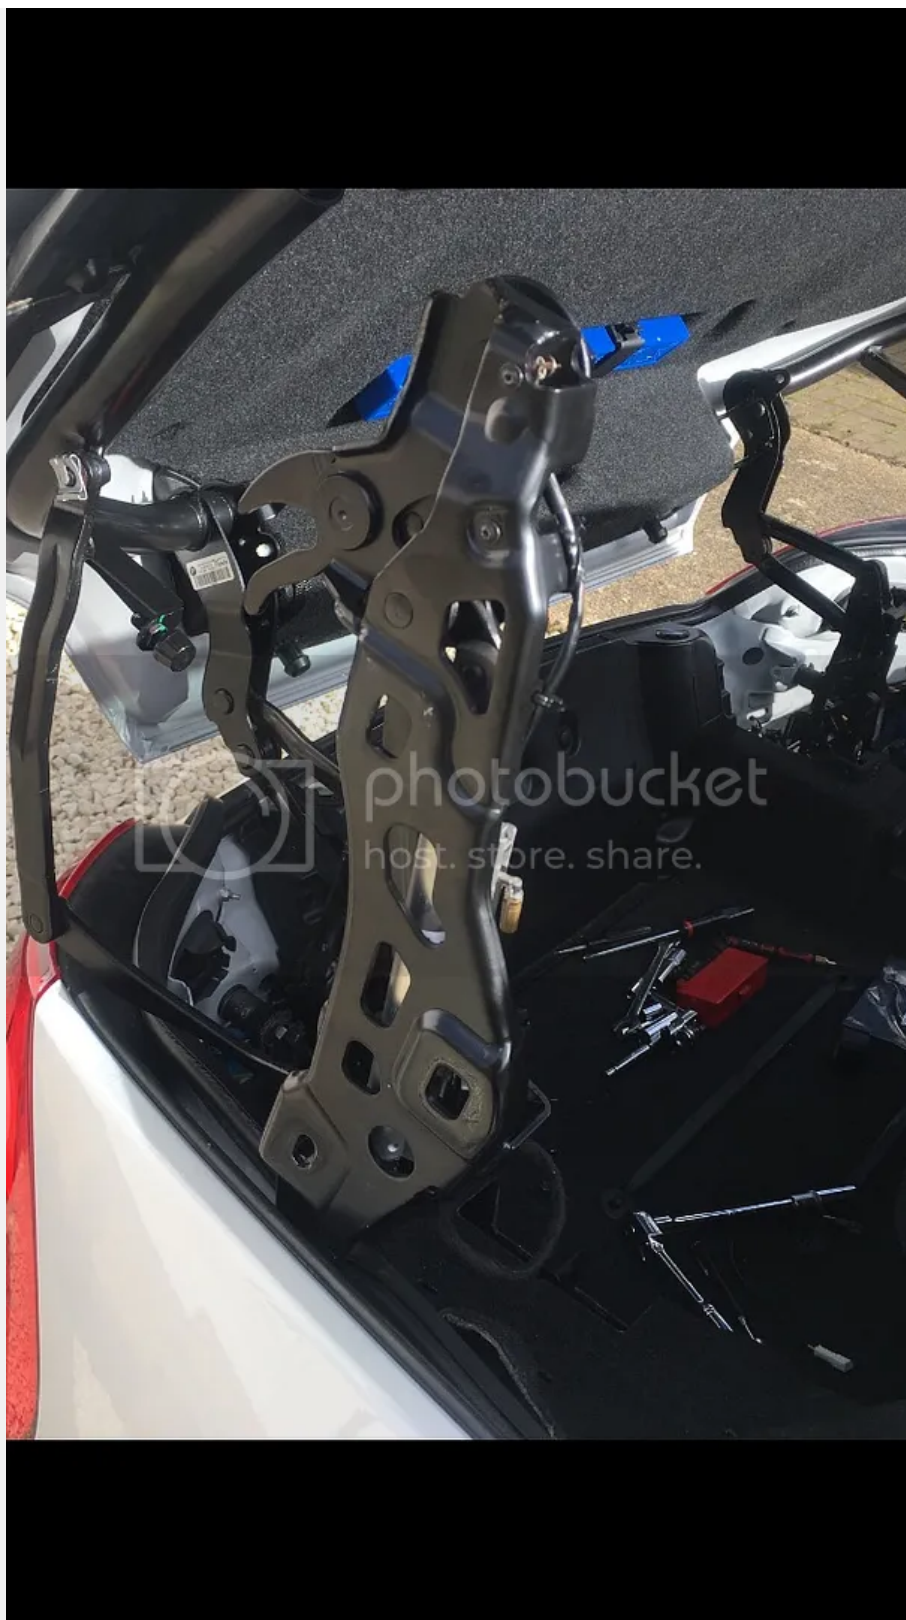
Having marked the nut positions , undo the 3 nuts and gentle wiggle the hinge upward and out of the boot space, you do not need to undo the hinge connection to the boot lid, but you may have to tease the hydraulic lines up from where they are mounted, I didn't but it was tight . Take care not to scratch your paintwork ( I used a work mat , but a few layers of masking tape will do ) . With the hinge upright you can now see the two hall sensors on the ram and the micro switch at the end of the hinge .

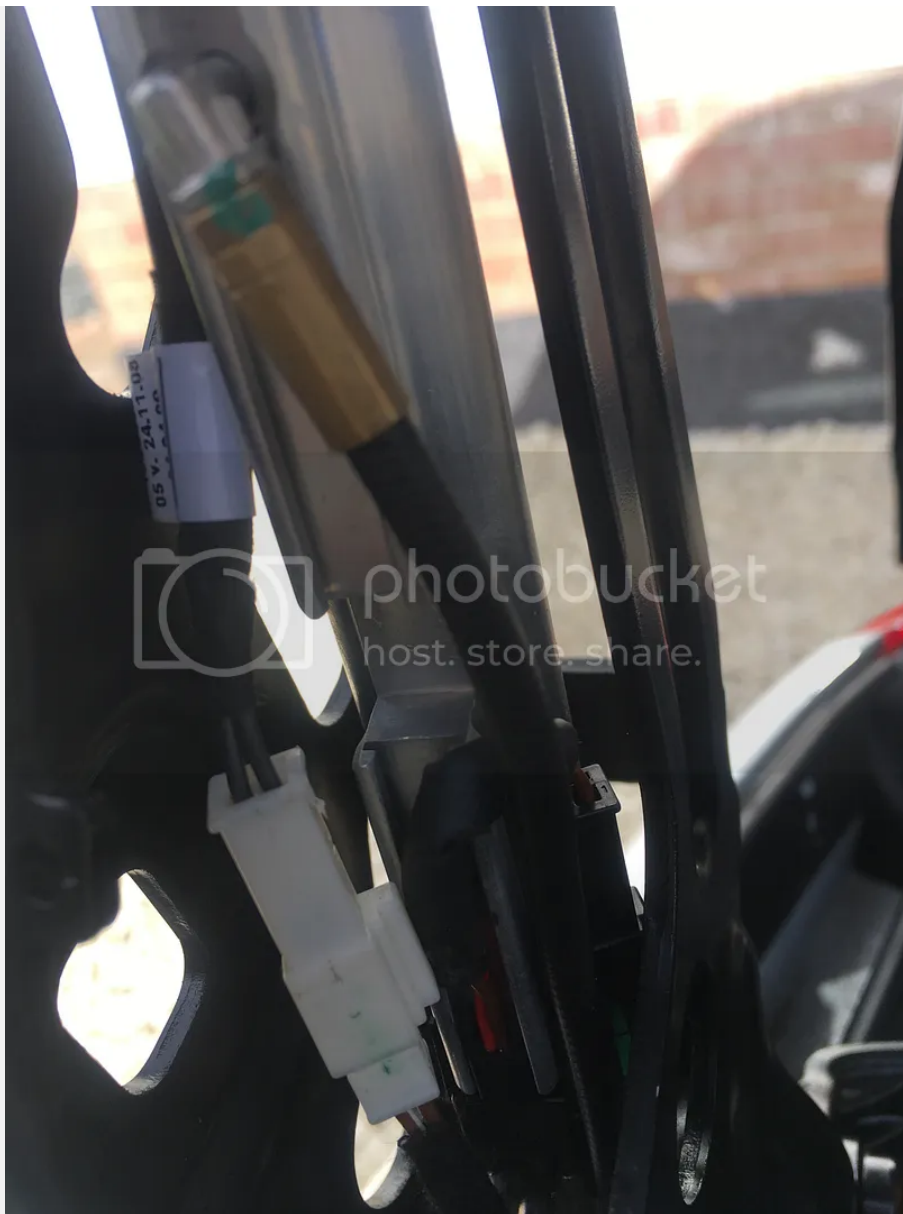
How Hall sensors locate in the ram casing

When I carefully inspected the old hall sensor I can see it is cracked around the outer edge so this may be something to check for. It's only a magnet but I guess any damage could cause issues.

I had bought both a micro switch for the right hand hinge( they are handed ) and one of the hall sensors ( they are both the same sensors , but from new,the car will have one with a short lead and one with a long lead , as a spare part they only sell the long lead version !) however, the connector on both the micro switch and the hall sensors have been changed from the old versions to new ones ,so you may have to chop the new connectors off the new plug and solder on your old plugs to facilitate proper connection. This is what I had to do for the Hall sensor( BMW technical services tell you this is your only option for the hall sensor connectors,( see pictures below ) the micro switch connector is available with some additional parts to modify but honestly I'd chop and swap these too if I had too, it's very easy) .

that too ( it just unscrews with two small screws ) I fitted the new hall sensor (with chop and swap plug ) and refitted the hinge . With every wire carefully cable tied back into position I closed the roof completely , pressed the open button and .....result it's all back to working as it should .

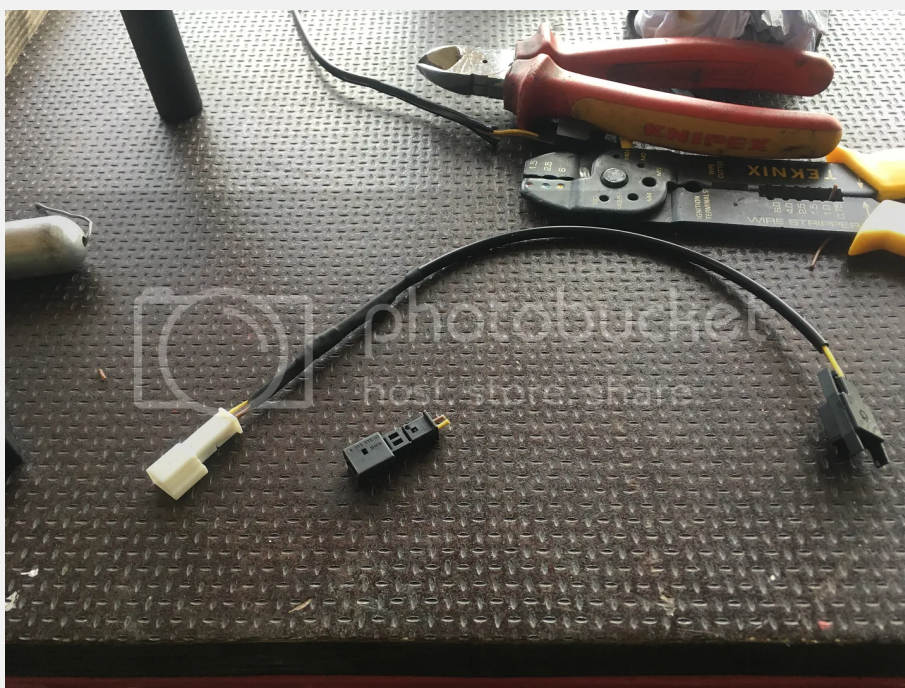
Black is the new type connector, white is the old type .
